**National Sedimentation Laboratory  
Channel and Watershed Processes Research Unit  
Oxford, Mississippi 38655**

**Sediment Quality Issues within a Flood Control  
Reservoir, Little Tallahatchie County, MS**

**By Sean J. Bennett**

**Research Report No. 23**

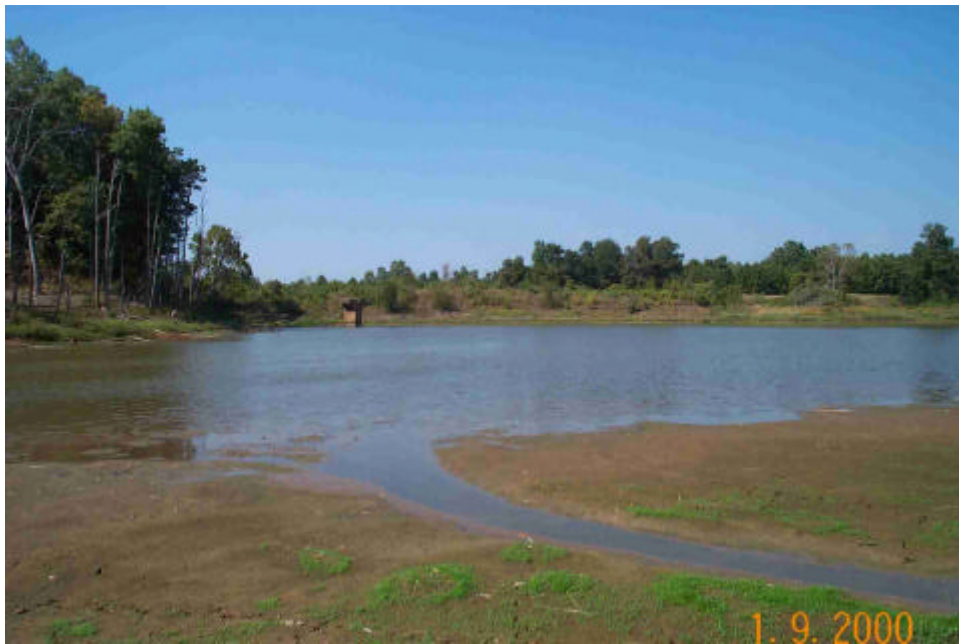
Figure 1. Photograph of Hubbard-Murphree reservoir looking directly north showing principal spillway and earthen embankment in distance (September 2000).

Hubbard-Murphree Dam Y-17-73 is located near Charleston, MS and it is a relatively small lake with a mud bottom and fairly shallow water depths (up to 2 m; Figures 1 to 5). Dam construction was completed in the early 1960's. The structure was designed with storage capacities of 104 acre-feet for sediment and 735 acre-feet for floodwater. The reservoir has an upstream drainage area of 2,030 acres (822 ha). Approximately 4% of the watershed is currently cultivated, 42% is steep woodland, 36% is woodland, 18% is pasture, and less than 1% of the area is covered with roads. A base map of the dam and its environs constructed from DGPS information is shown in Figure 6.

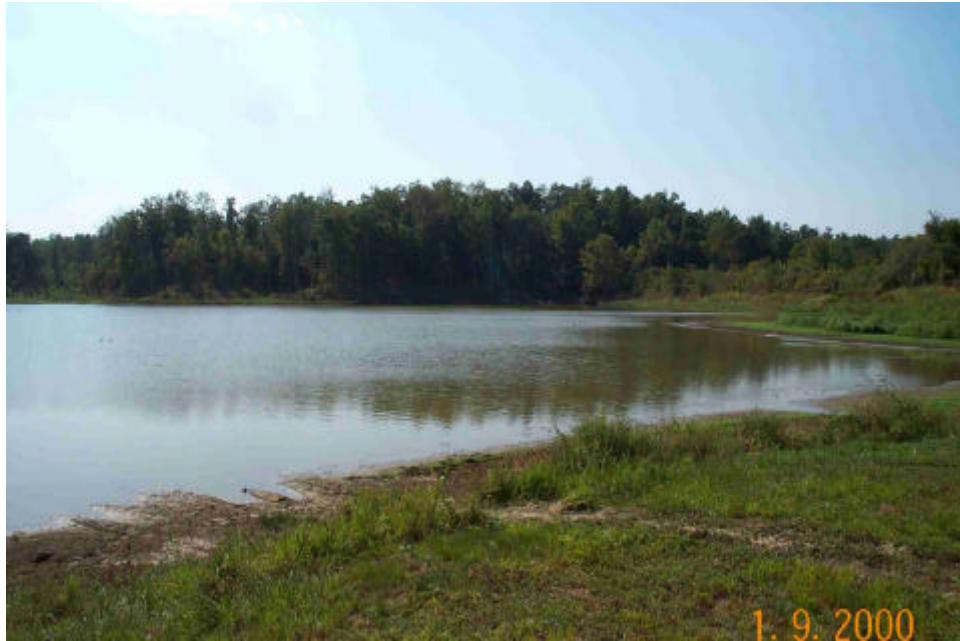
Figure 2. Photograph of Hubbard-Murphree reservoir looking directly west. Principal spillway and earthen embankment are in distance on right (September 2000).

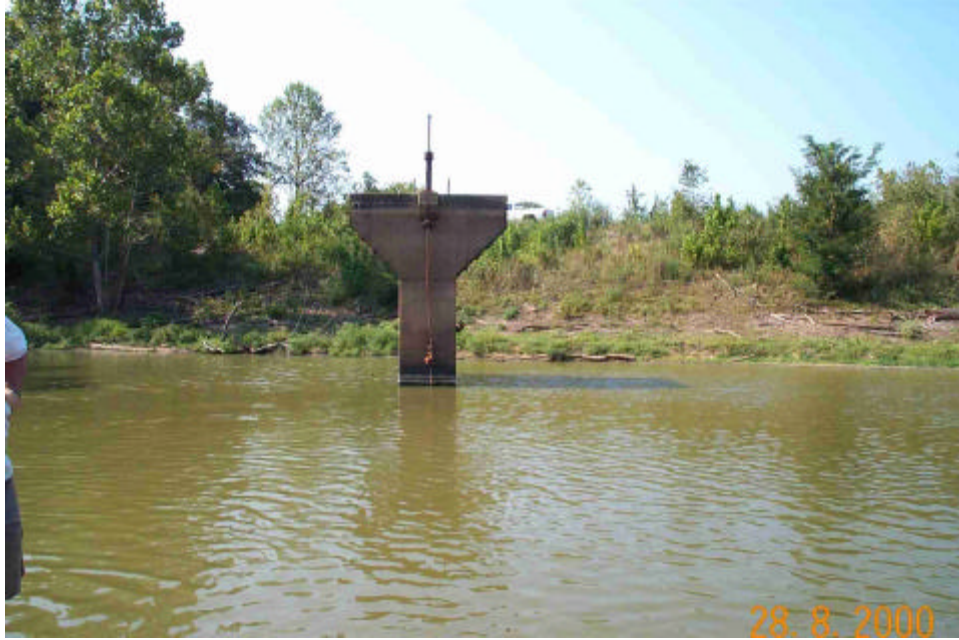
Figure 4. Photograph of principal spillway and earthen embankment at Hubbard-Murphree reservoir (September 2000). Note that the principal spillway is in disrepair and that the current water level is well below the designed stage.

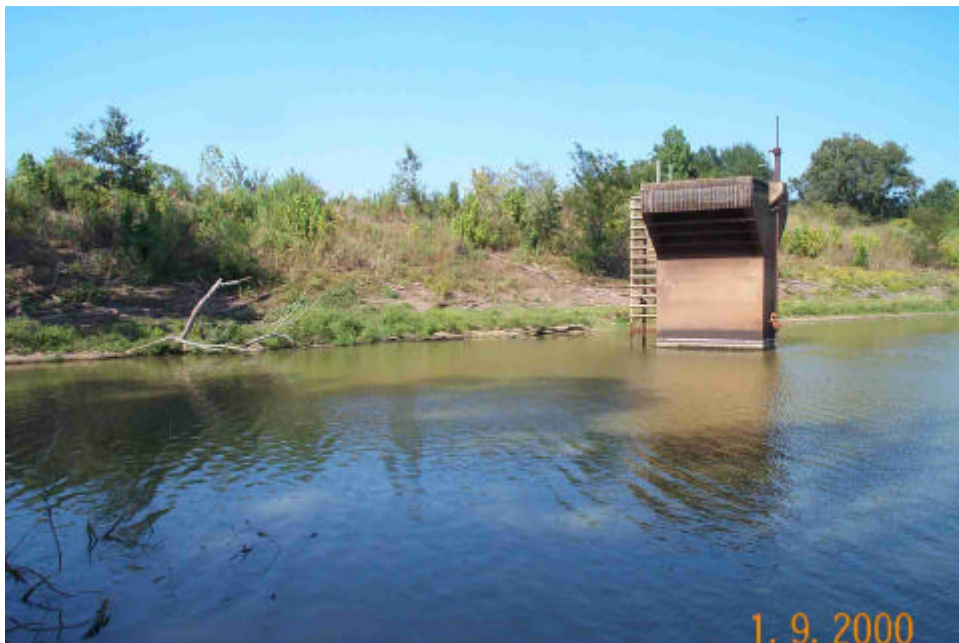
Figure 5. Photograph of principal spillway and earthen embankment at Hubbard-Murphree reservoir (September 2000).

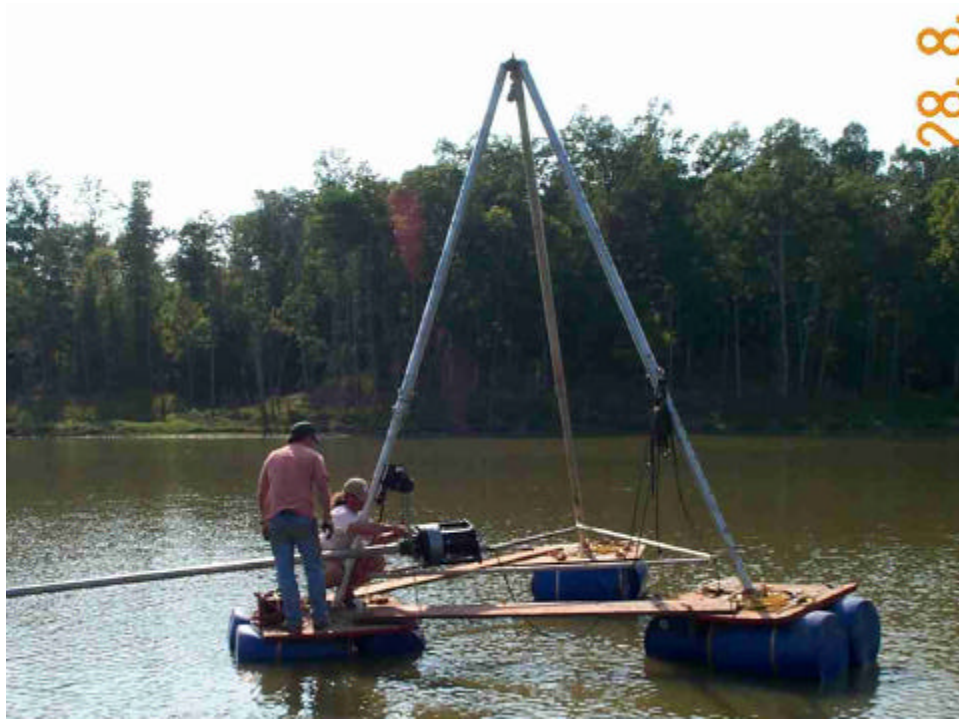
Figure 7. Photograph of floating vibracore system showing the tripod and portable rafts. A core pipe is being connected to the vibracore head (September 2000).

A commercially available vibracoring system was used in this study (Figures 7, 8, and 9). This system uses a 1-HP motor that drives a pair of weights (masses) eccentrically mounted on two shafts and housed within a water-tight aluminum chamber (Figure 9). When in operation, the masses rotate in opposite directions causing the chamber to vibrate at frequencies ranging from 6000 to 8000 RPM depending upon the sediment substrate. The chamber (driver) is connected to the top of an aluminum irrigation pipe 1.5-mm thick, 76-mm wide, and over 3-m long and cabled to a 4.2-m high aluminum tripod fitted with a battery-operated winch (Figures 7, 8, and 9). Since the driver is sealed, the entire system can be immersed in water. A simple check valve placed into the flange connecting the core pipe to the driver induces internal suction during core extraction. The tripod is mounted to a raft that can be easily carried and assembled on site, towed with a small boat, and anchored into position (Figure 7).

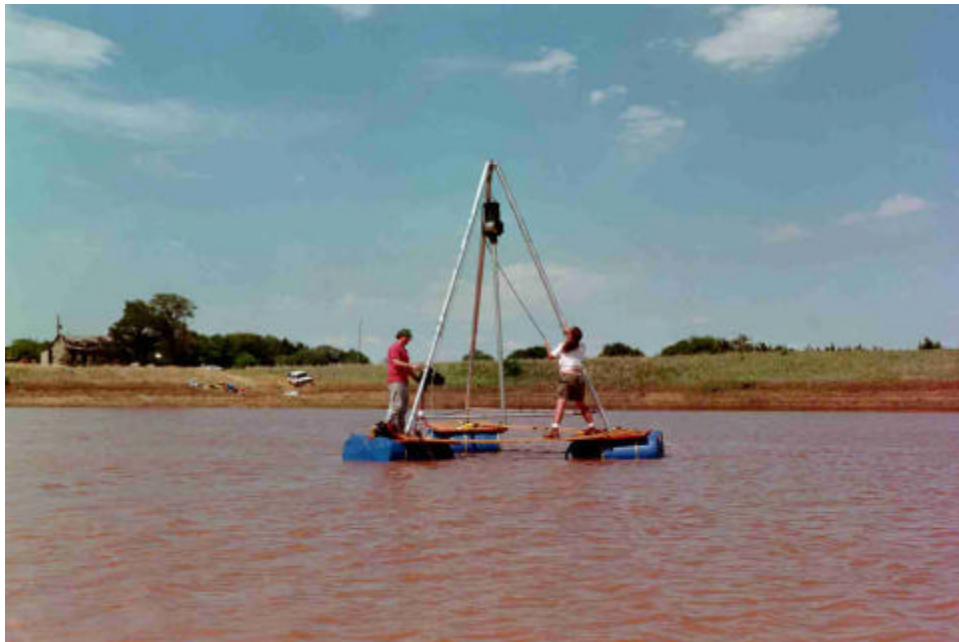
Figure 8. Photograph of floating vibracore system showing the tripod and portable rafts. The pipe is being positioned to obtain a core (photograph taken in Oklahoma, June 2000).

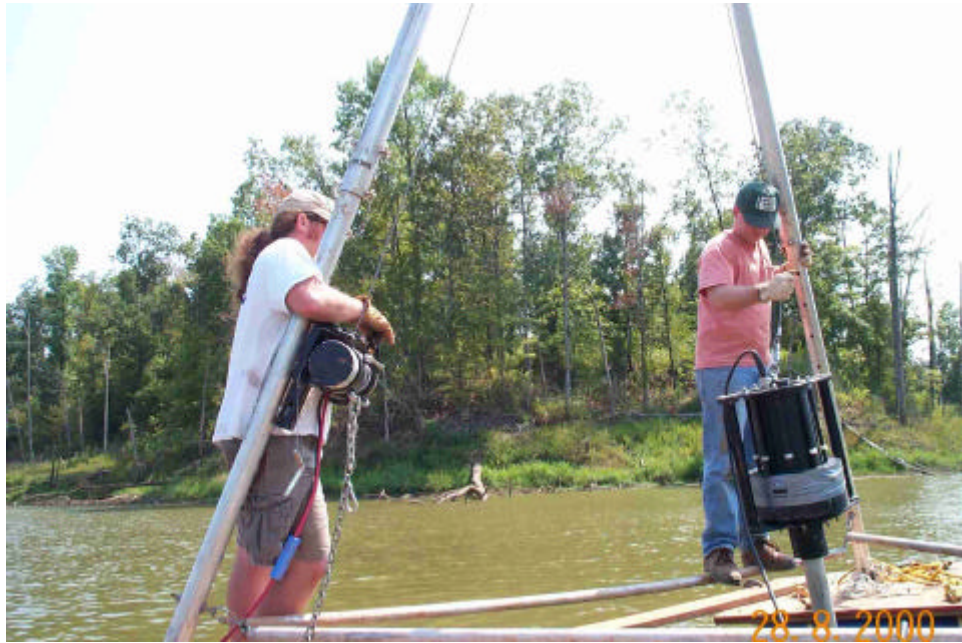
Figure 9. Photograph of vibracore system showing the tripod, vibracore head, and winch and cable assembly (September 2000).

Once the core was driven into the sediment, the vibrating motion was stopped and the winch lifted the core to the water surface (Figure 9). When successful, the core typically had a hard sediment bottom that acted as a seal. If excessive sand or gravel was present at the bottom of the core, the entire contents of the pipe would be lost during lifting. The position of the raft was recorded with a hand-held GPS receiver whose data were differentially corrected using available base station information. The core was transferred to the boat and transported to shore. Each core was transported back to the National Sedimentation Laboratory and opened by cutting the aluminum pipe length-wise on both sides with a circular saw, and the top half of the pipe was carefully lifted from the sediment (Figure 10). Typical photographs of the sediment within a core are shown in Figure 11.

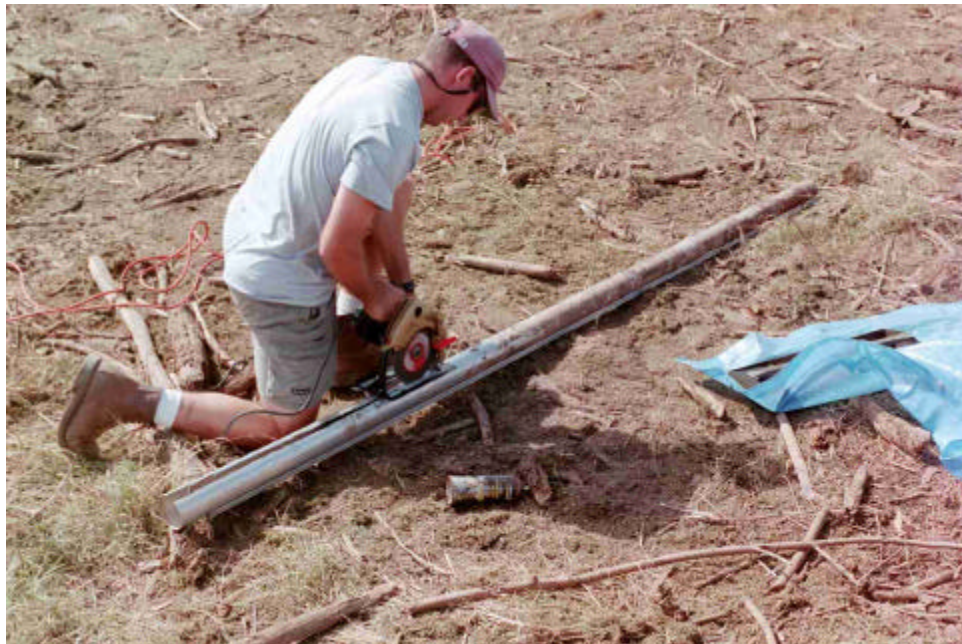
Figure 10. Photograph of extracted core being cut open on-site (photograph taken in Oklahoma, June 2000).
